Continuation of Studies on Development of ODS Heat Exchanger Tubing

Final Report
Cooperative Agreement No.: DE-FC26-05NT42238

Reporting Period:
February 28, 2005 through April 15, 2008

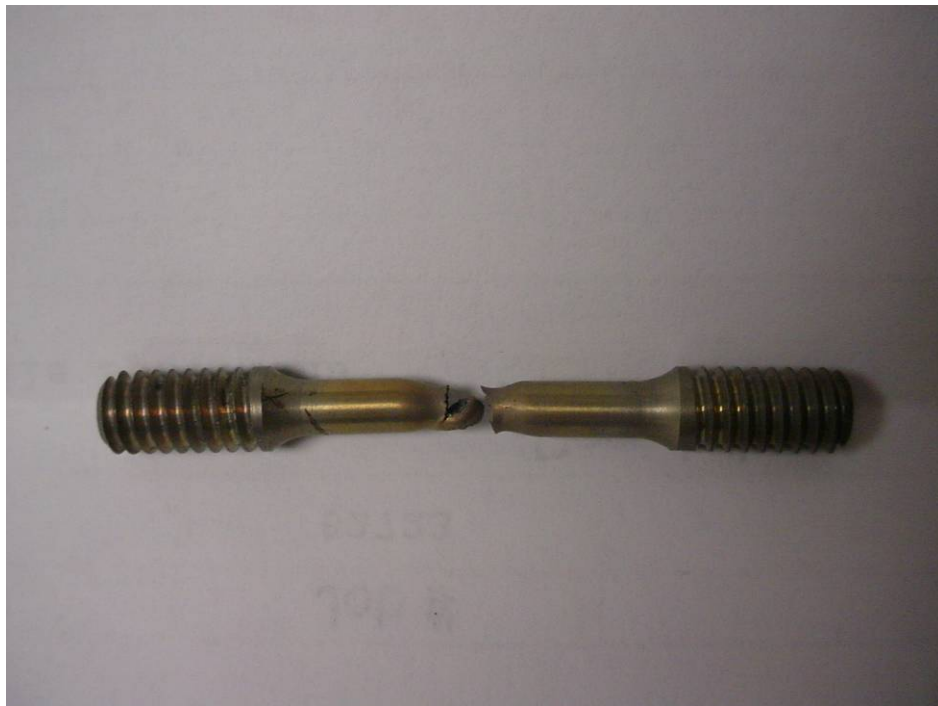
Figure 60. Failure of Samples Produced using Flash Butt Welding showing Necking in HAZ Regions

The flash butt welds failed at lower stress levels and produced lower yield strengths. However, it was noted that the failures occurred in the heat affected zones and not on the bondline of the flash butt welds. There were two areas of necking observed in the failed samples on each side of the bondline as shown in Figure 60. Failure location appears to coincide with the location of maximum grain orientation change and growth in the as welded cross sections shown in previous activity summaries. These results again suggest that the orientation of the grains in the weld and heat affected zone are critical as the flash butt welds showed the greatest degree of grain direction change in the heat affected zone. This feature is most likely driven by the fact that in an inertia friction weld, the area of grain direction change undergoes some straining via the torsional stress applied during the friction welding process resulting in an increased level of cold work in this area of grain direction change. The flash butt weld heat affected zone is simply upset with material being forged out of the joint.

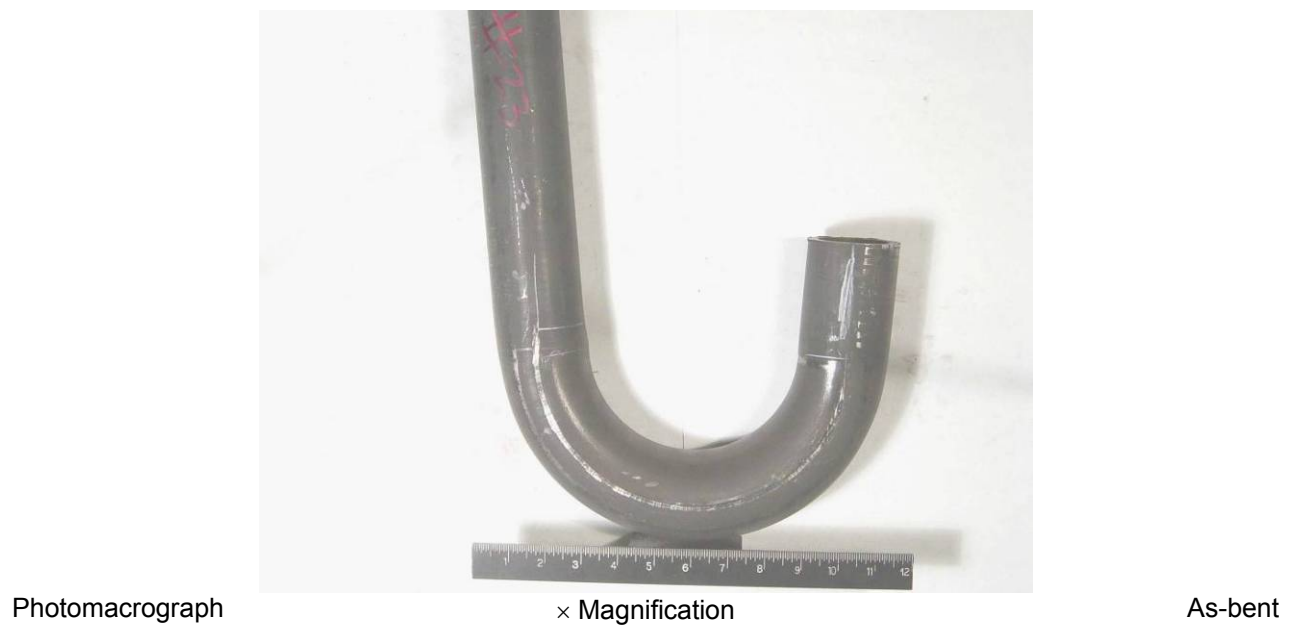
Figure 74. Appearance of 107.95 mm (4.25-in.) Radius (1.7D) Bend Illustrated

The first attempt to make the 107.95 mm (4.25 in.) radius bends was tried on the commercially annealed material after just heating the tube to 204.4°C (400°F). The tube failed circumferentially at the start of the bend. When a narrow strip was heated to a red hot condition on the side of the tube that was to become the intrados of the bend, similar to that done on the modified annealed material for the 127 mm (5 in.) radius bends, the bend was made without a problem. A second bend on the commercially annealed material and two bends on the modified annealed material were made using this procedure. The representative appearance of the 107.95 mm (4.25 in.) radius bends is displayed in Figure 74.
